Kingwood Drainage Study

Conceptual Watershed Plan for Flood Damage Reduction in Kingwood

HCFCF Project ID#: Z100-00-00-P027
Bond Program Map ID F-14

Harris County, Texas

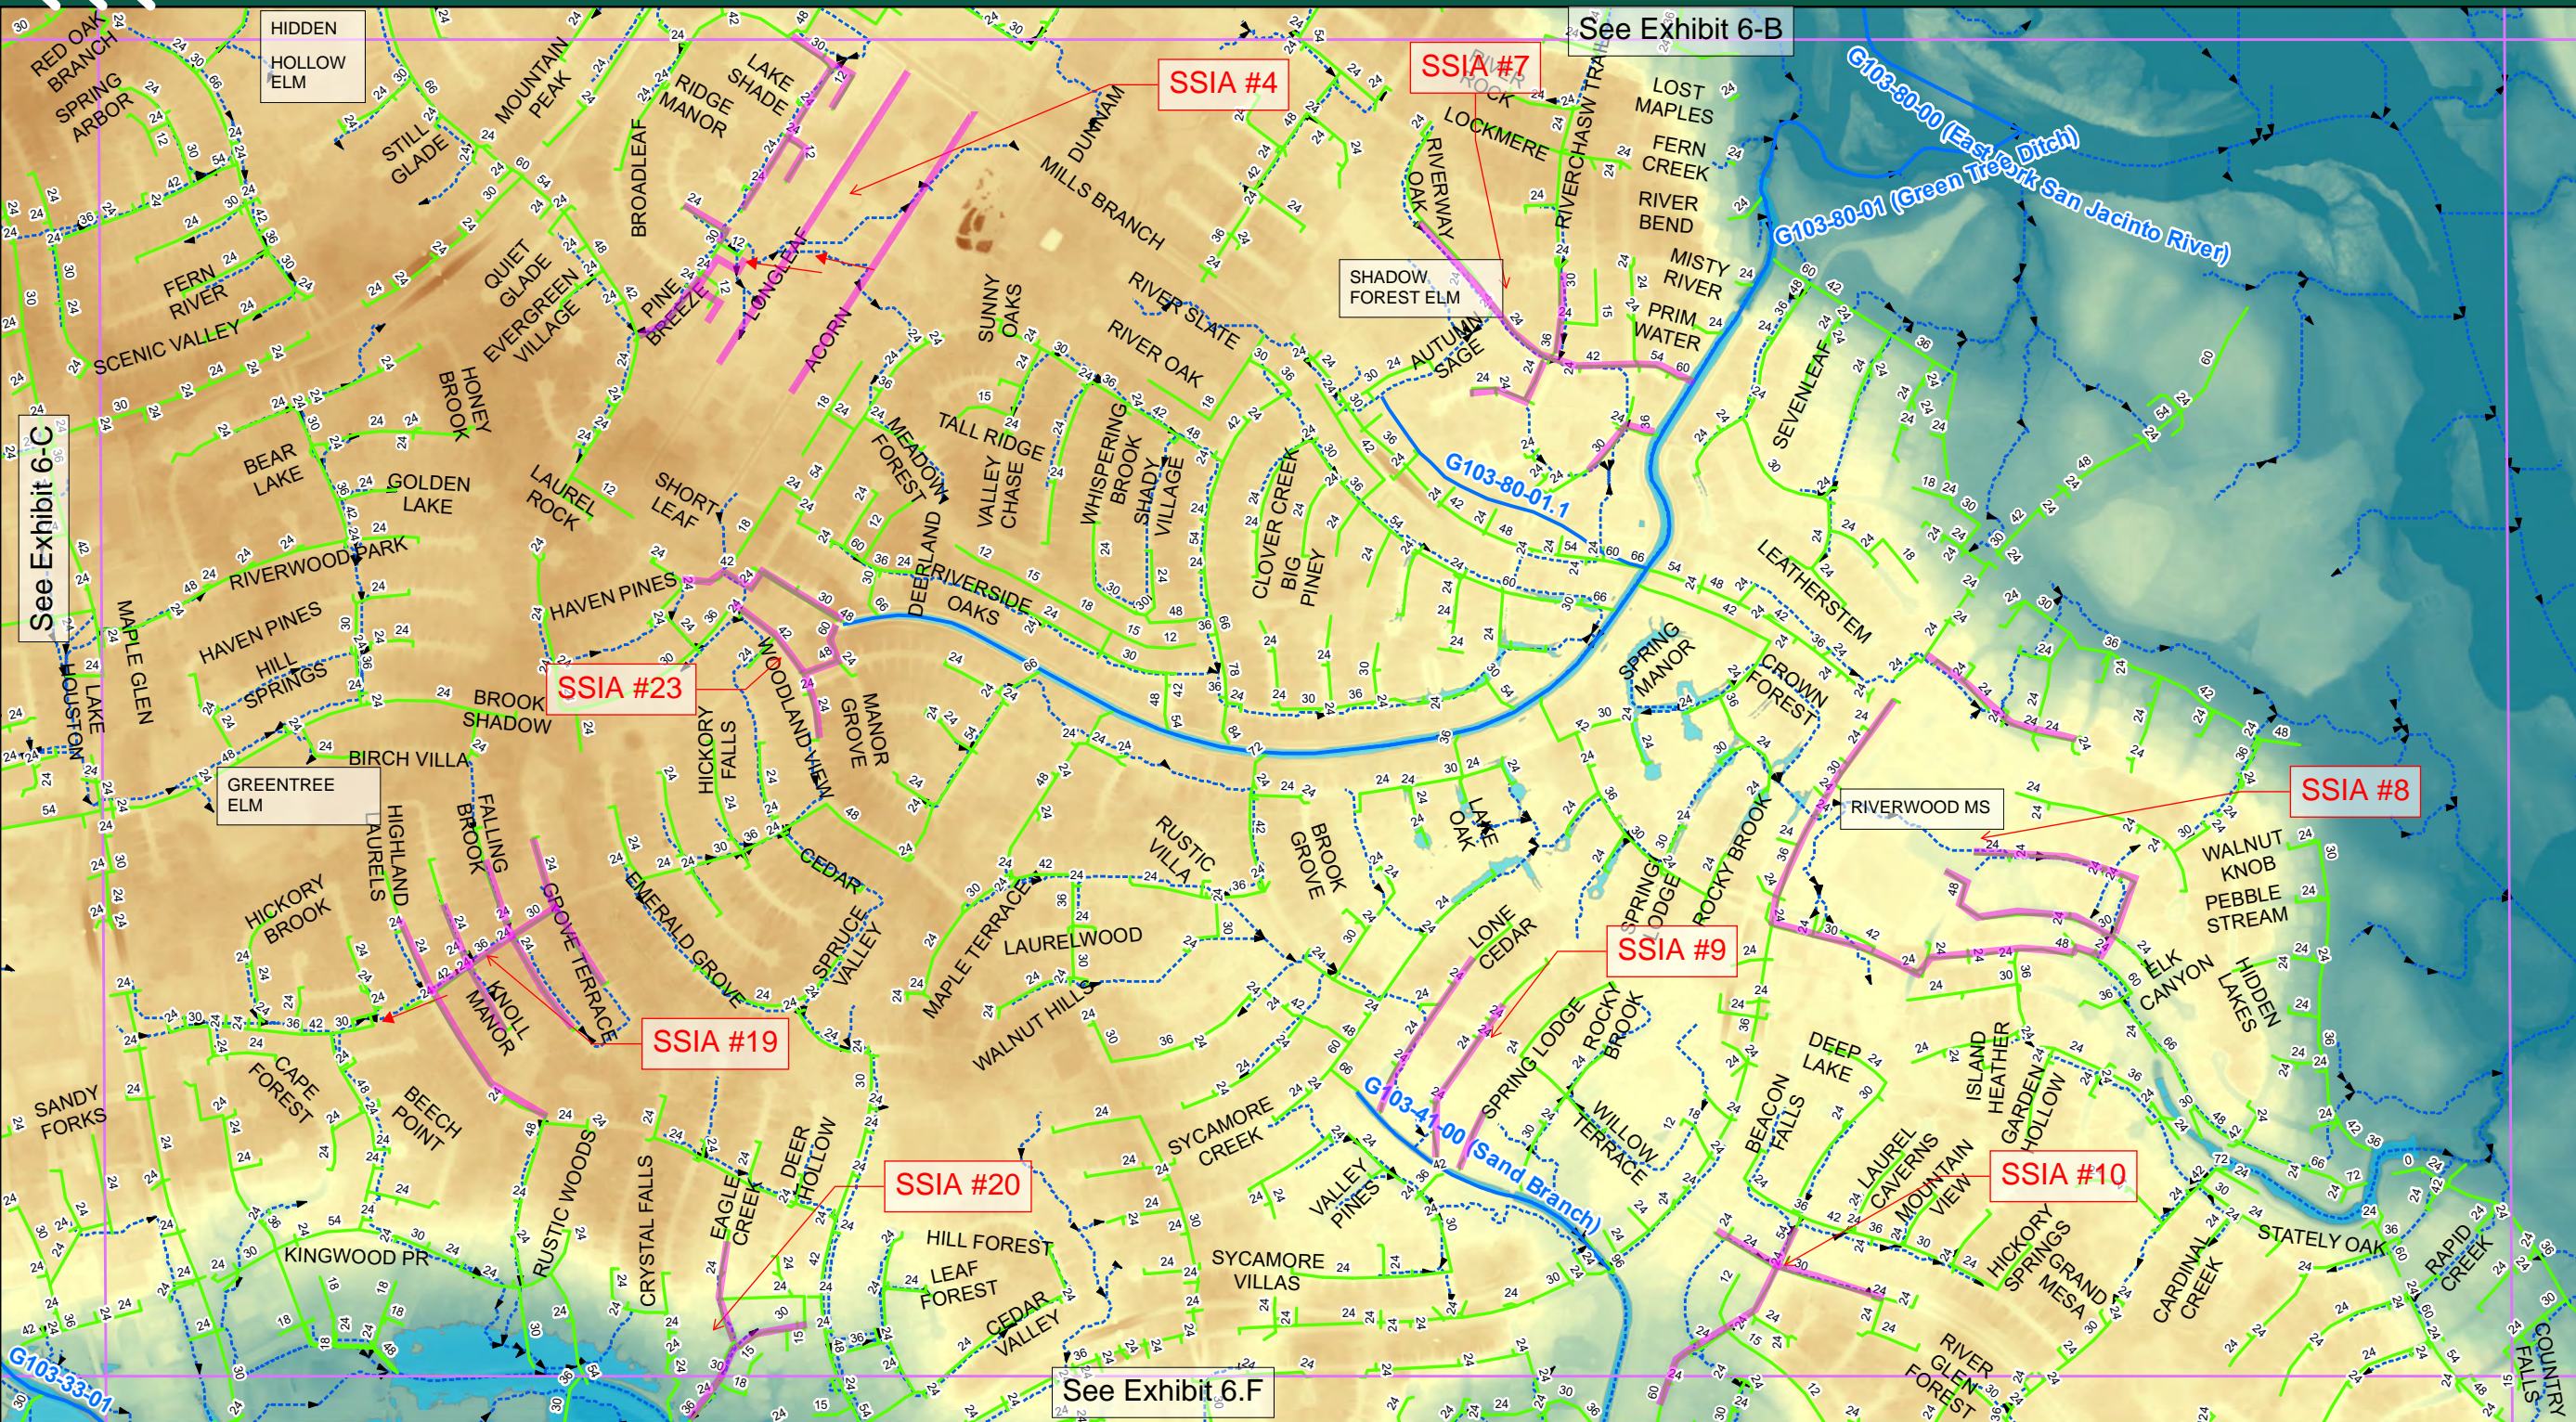
Legend

- Streams
- Storm Sewers - Exist
- Flow Paths
- County Boundary
- 1% AEP

SSIA = Recommended Storm Sewer Investigation Area
